Kootenai River Habitat Restoration Phase 1

September 19, 2011

Kootenai Valley Resource Initiative

Phase 1 Update -

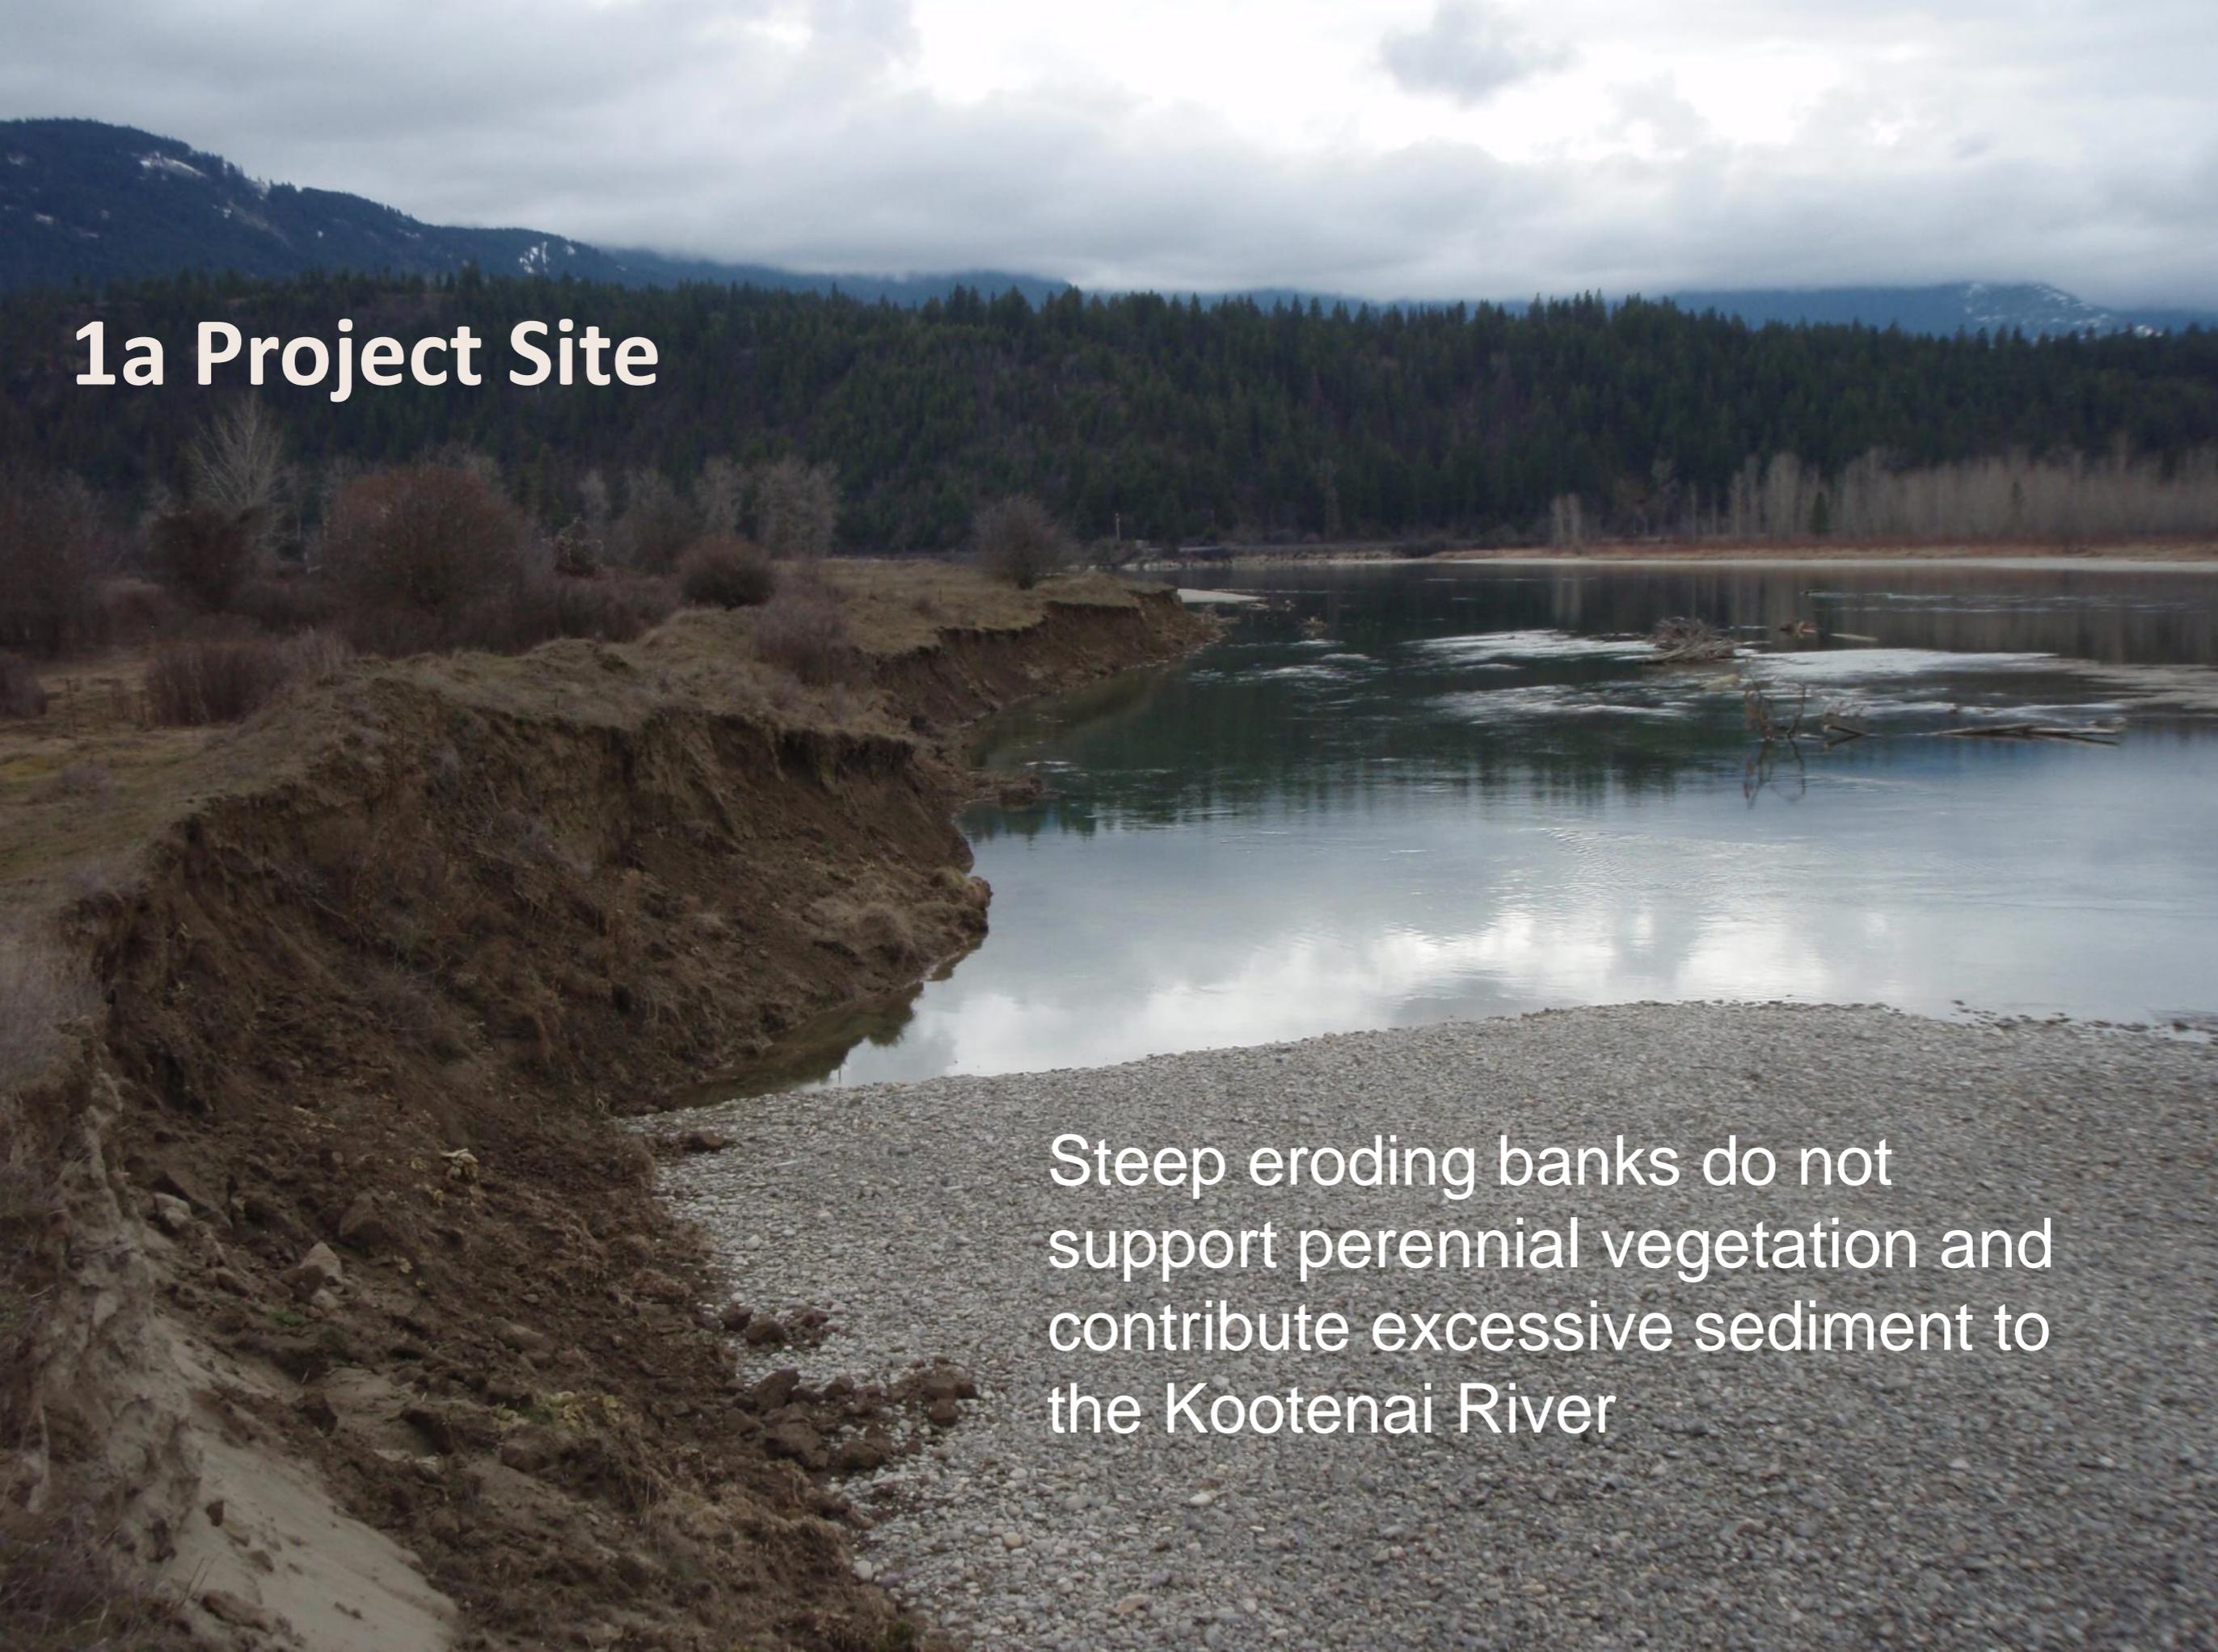
1a Project Site

A landscape photograph showing a river with a steep, eroding bank on the left and a gravelly shore in the foreground. The background features a dense forest and mountains under a cloudy sky.

Steep eroding banks do not support perennial vegetation and contribute excessive sediment to the Kootenai River

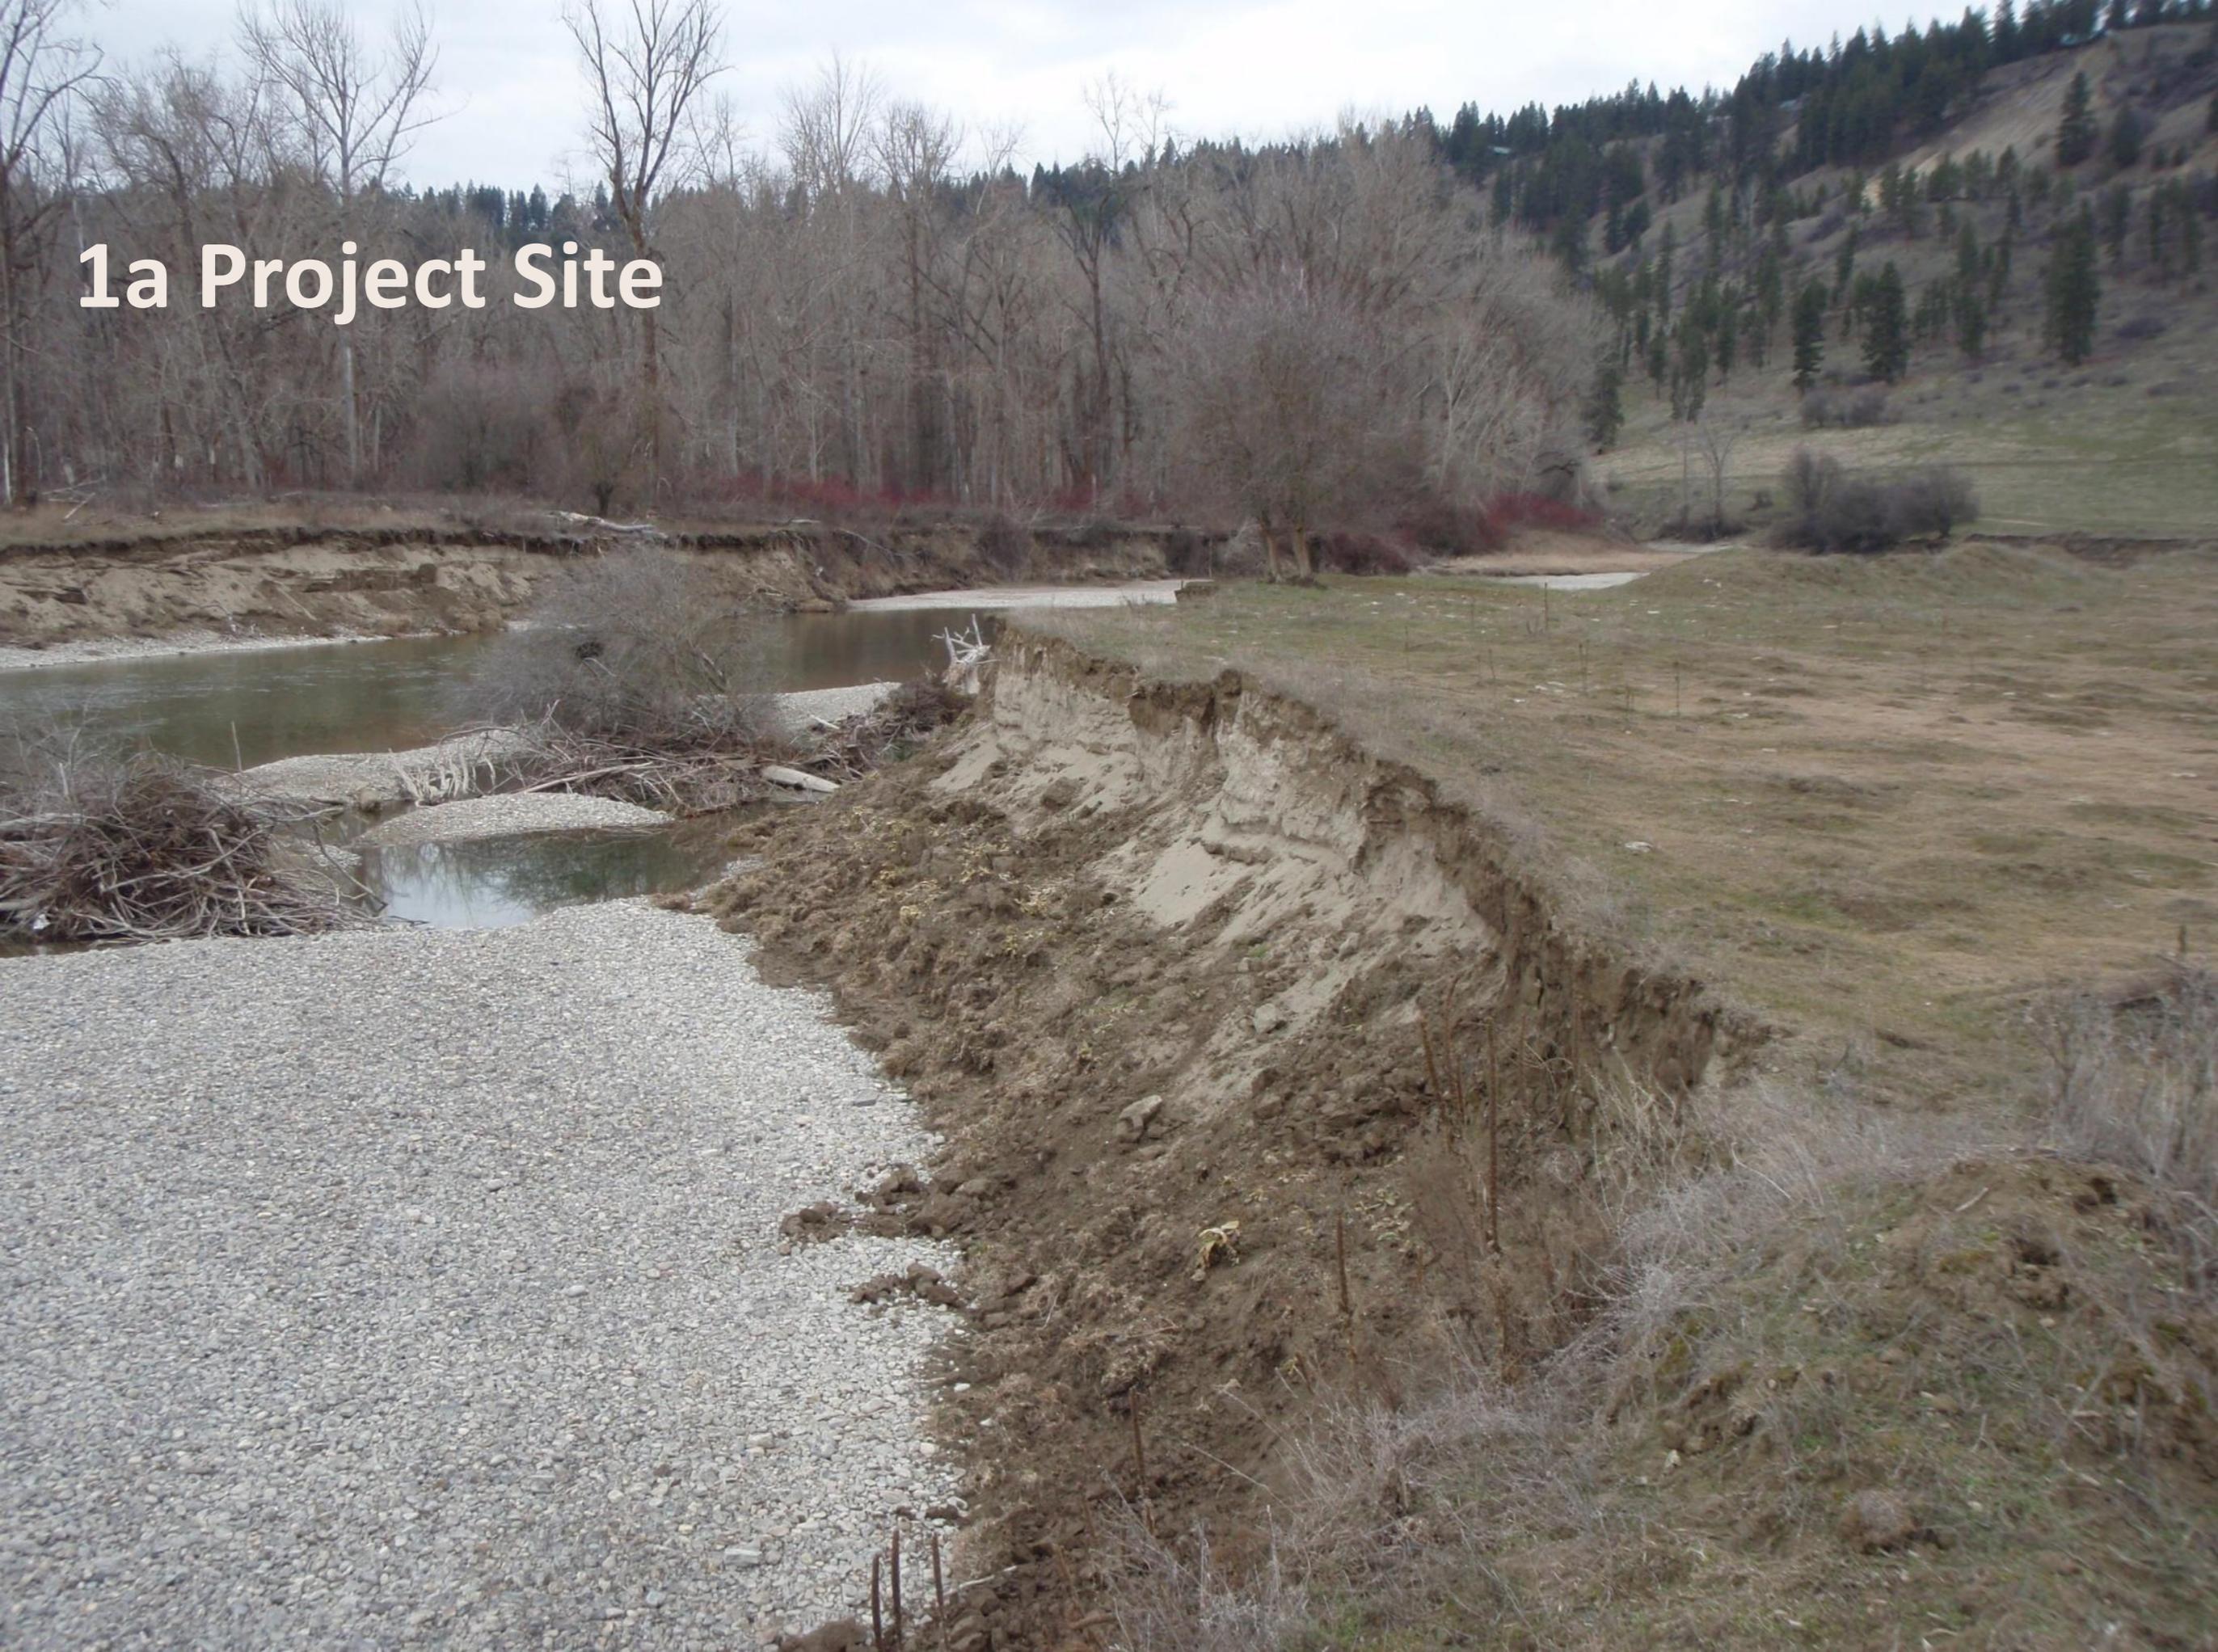
1a Project Overview

Large wood structures improve cover, complexity and pool habitat

Bank vegetation provides a riparian buffer and enhances aquatic habitat

Fencing installed to prevent floodplain/bank grazing

Large wood roughness elements protect toe of bank and promote sediment deposition

Eroded over-steepened banks re-graded and planted with riparian trees and shrubs
