# Public Safety and Pipeline Awareness Overview

Steve McNulty  
3/18/08

# GTN System Overview

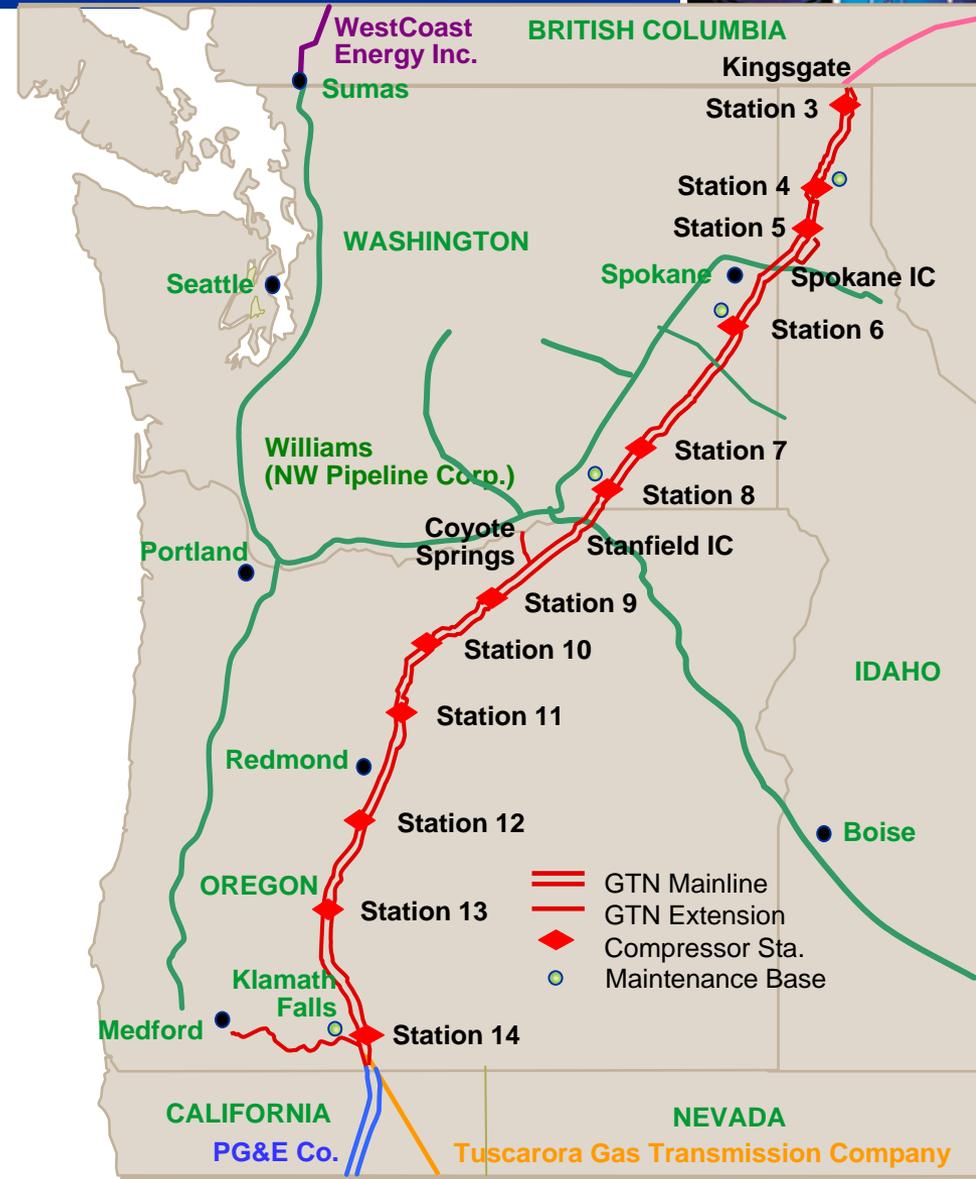
Kingsgate (Receipt)	2,894
Pacific Northwest (Delivery)	1,220
Malin/Tuscarora (Delivery)	2,191

610 miles of 42-inch mainline  
 639 miles of 36-inch mainline  
 23 miles of 16-inch extension  
 84 miles of 12-inch extension

12 mainline compressor stations  
 29 mainline compressor units  
 519,820 total system horsepower

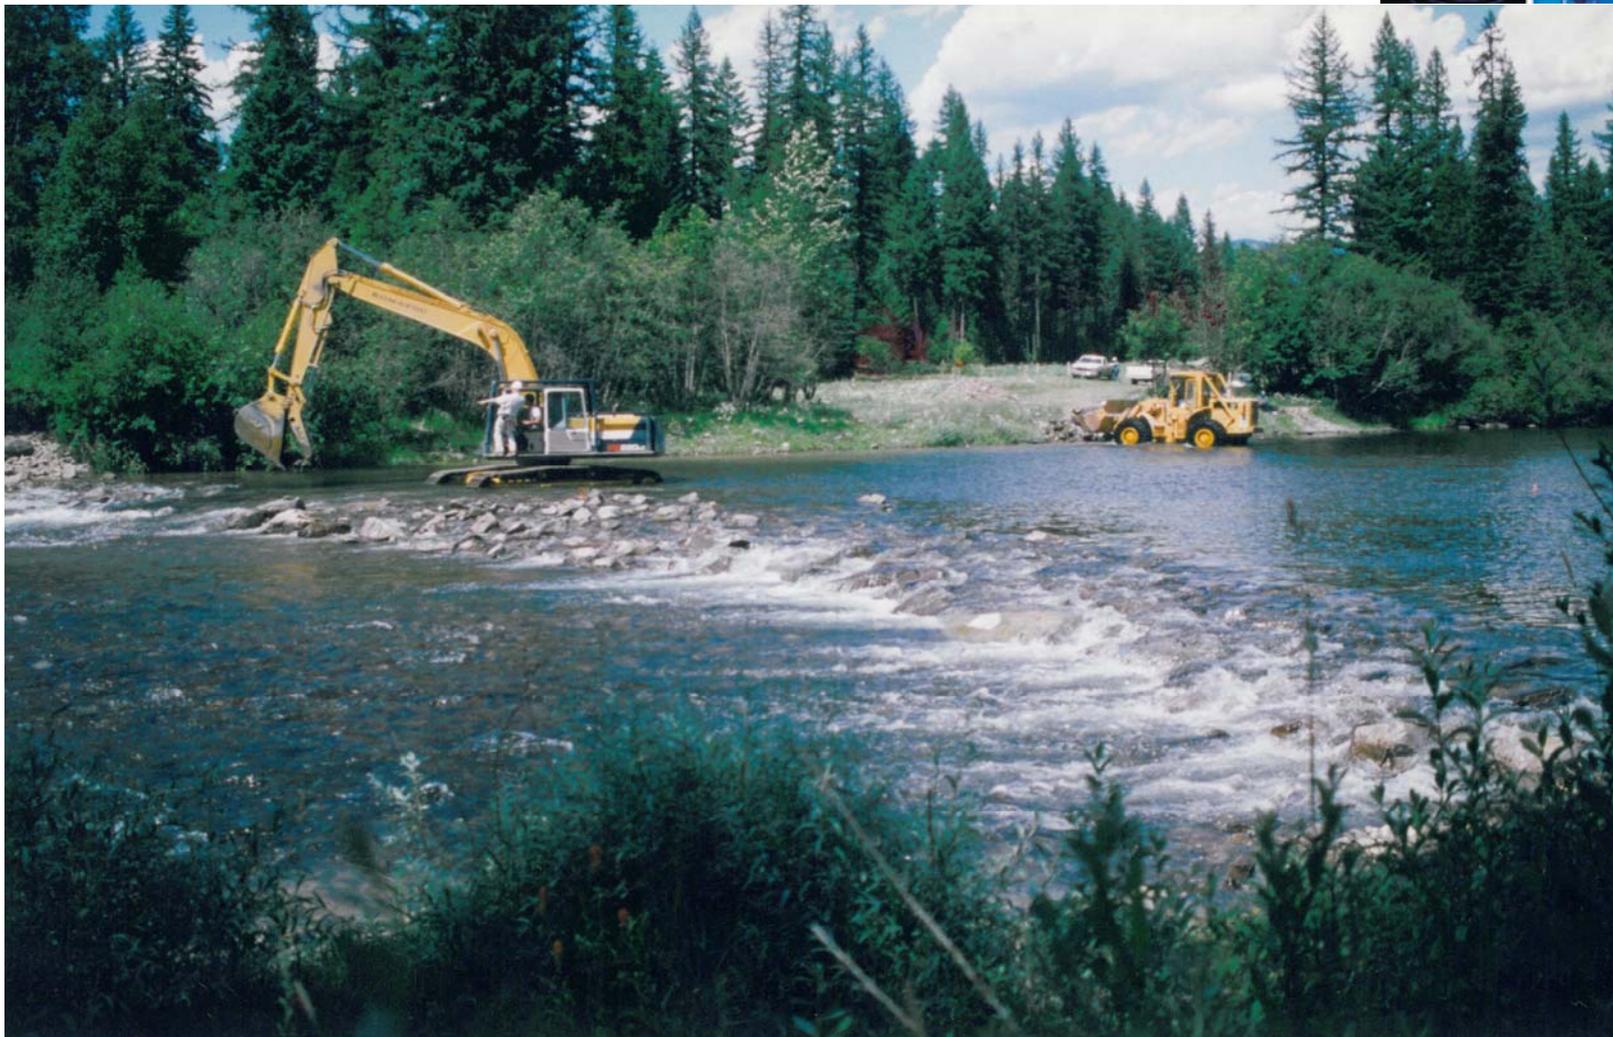
# Moyie River crossing with rock structures

- With the help of the U.S. Forest Service and Geomax engineering 35 rock structures were tailor-made for each crossing.
- The fish structures improve fish habitat, accelerate stream scouring, and enhance the depositional regime.
- For five years following the construction (1993-1997), GTN monitored the impact of our enhancement efforts.
- Results showed a 400% increase of the fish population.
